Technical Preservation Services
Preservation Assistance Division
National Park Service
U.S. Department of the Interior
Washington, D.C.

Interpreting the Secretary of the Interior's Standards for Rehabilitation

Volume III

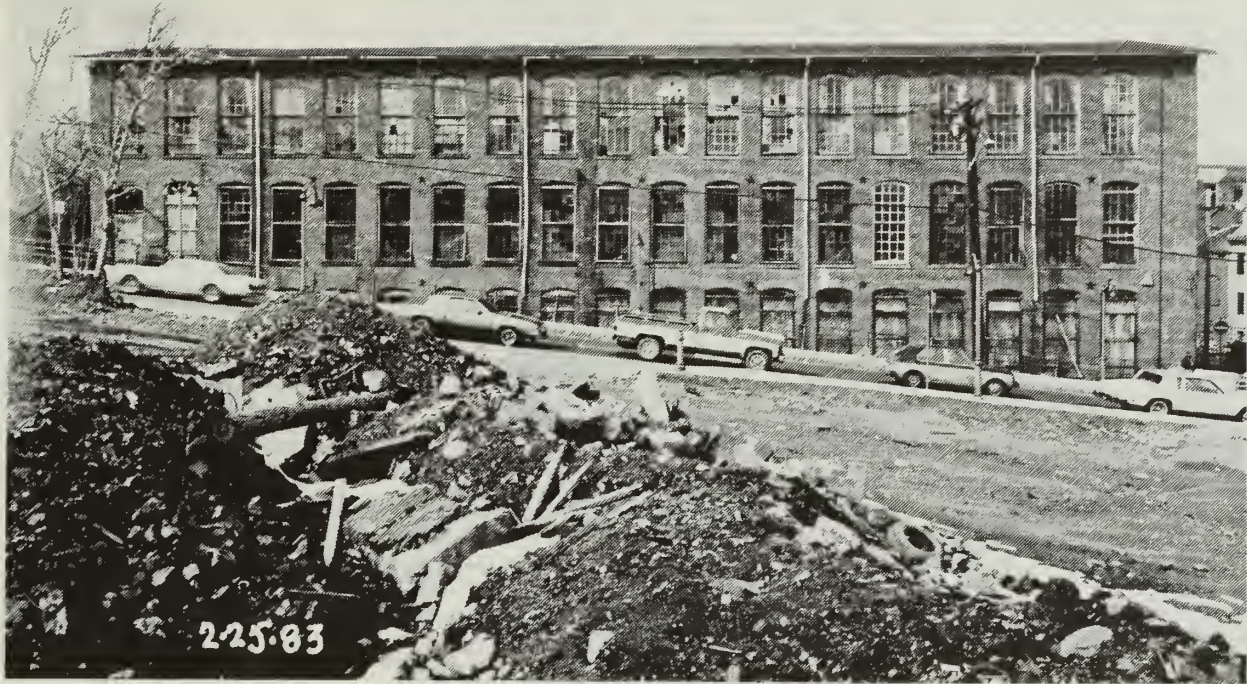
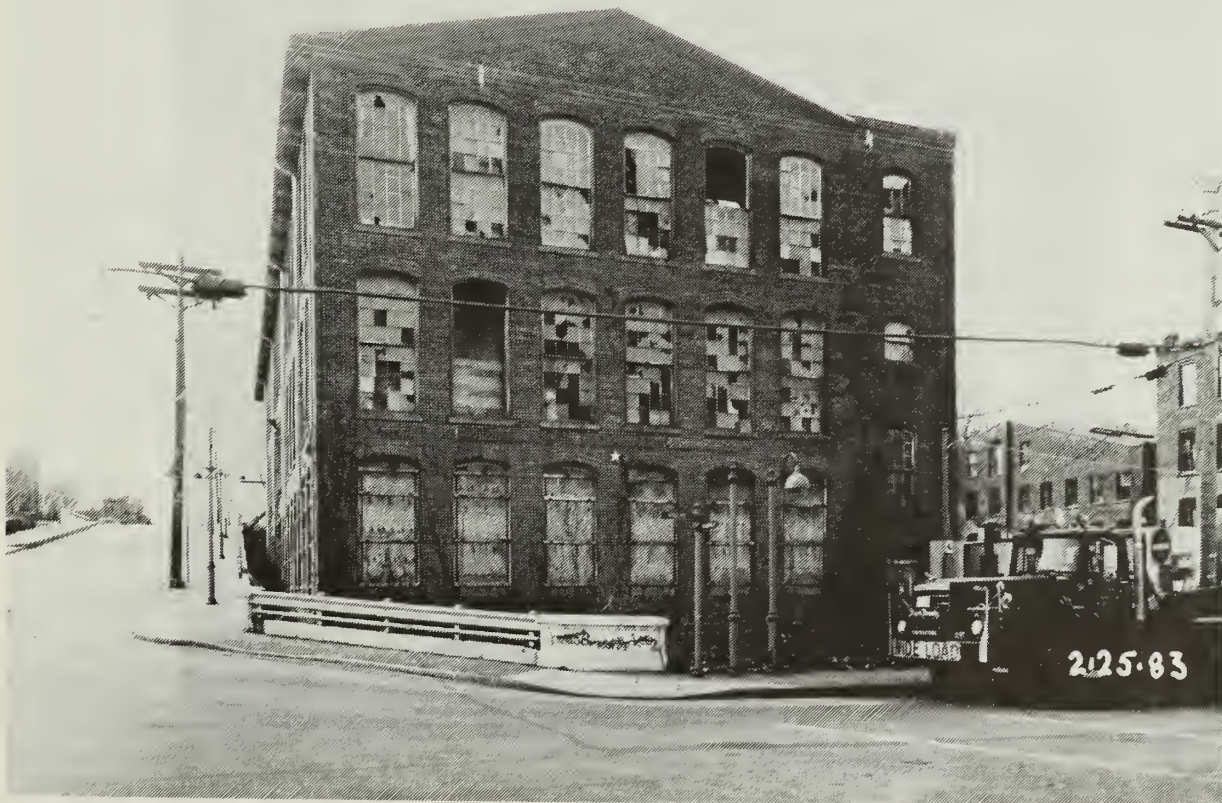
1.

1-2. Pre-rehabilitation view of the building showing deteriorated 16-over-16 windows. Note previous owner's effort to duplicate arch-headed sash with sample unit on 2nd floor. In the view below, note how the upper and lower sash are set on different planes, a characteristic feature of double-hung windows.

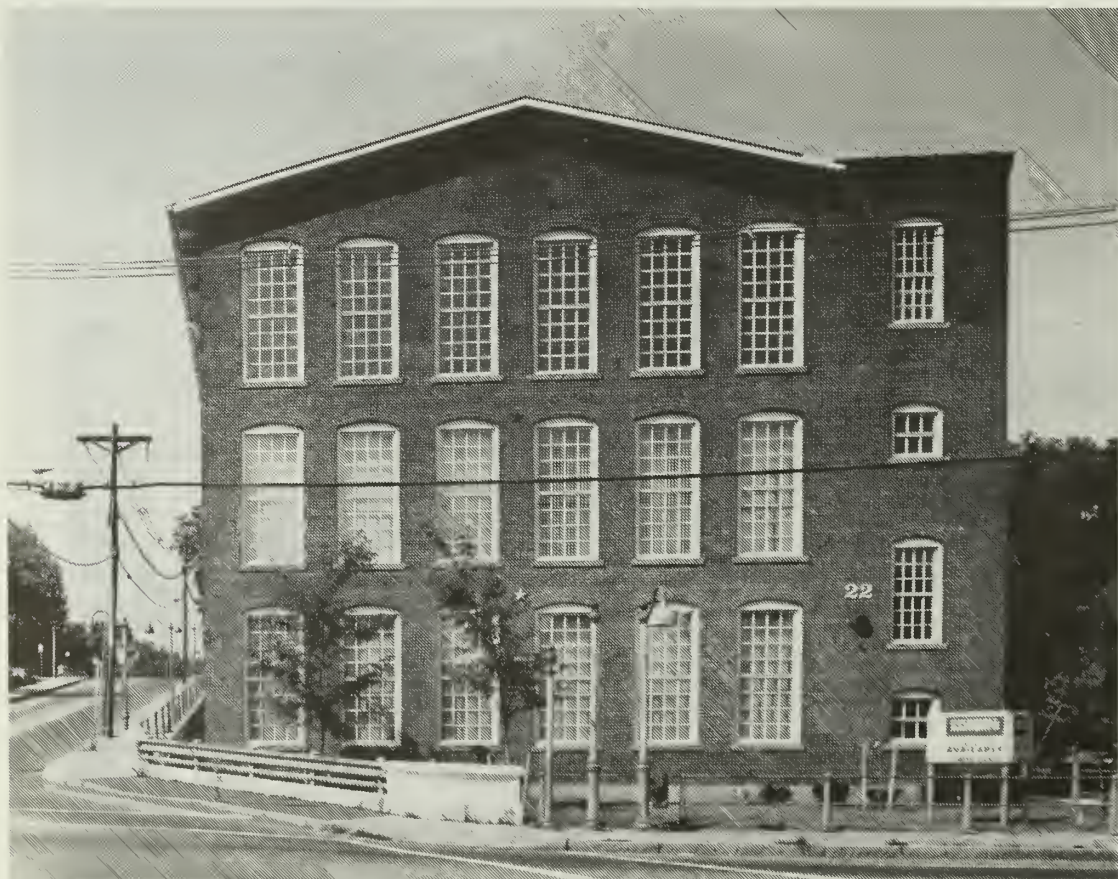
3.

3-5. Post-rehabilitation view of the building showing replacement windows. In 5, note how the reduction in depth of the meeting rail has produced a flat appearance to the window. The appearance of a historic double-hung window with sash on different planes and a heavy shadow line created by the meeting rail has been lost.

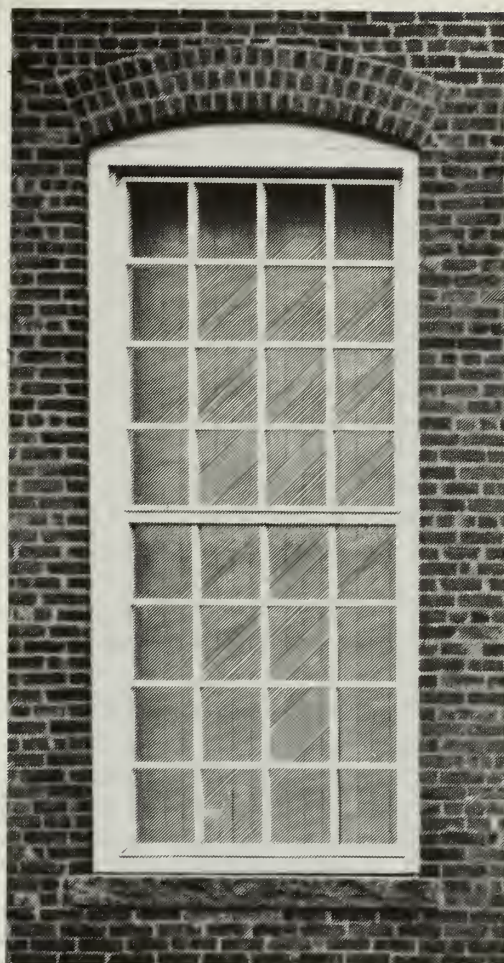
5.

Vertical Section of Replacement Window

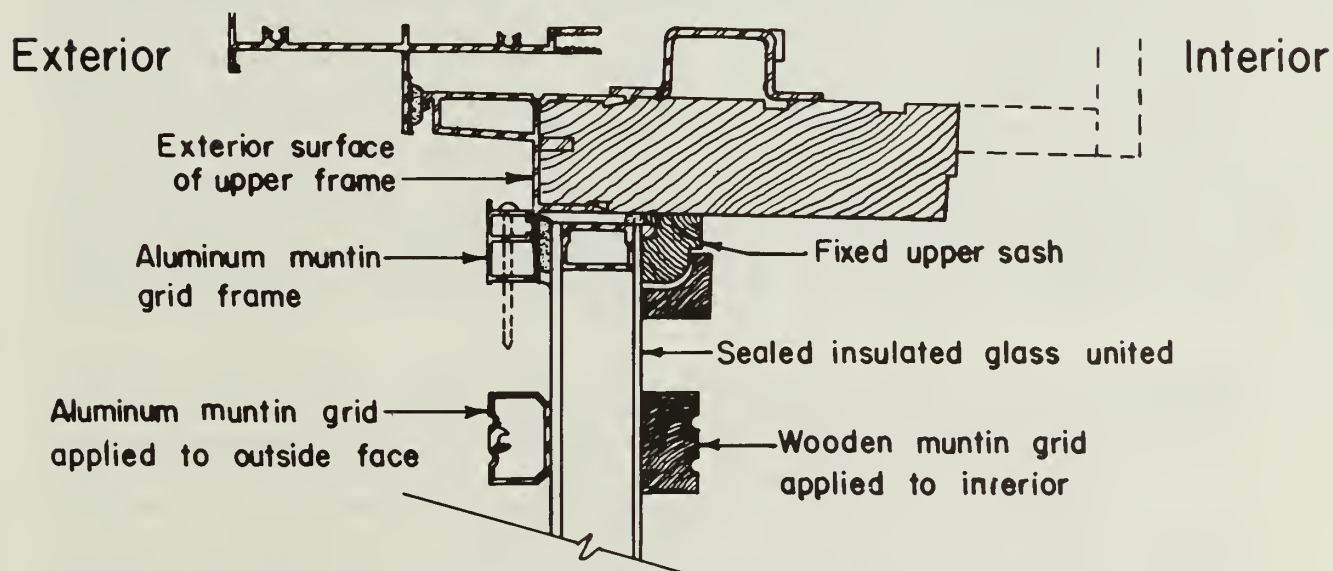
6. Shop drawing showing applied muntin grid projecting beyond the exterior surface of the sash. Also note rectangular shape and the two grooves on the interior and exterior muntin grids which produce the ribbed appearance and additional shadow lines that did not exist on the historic windows.

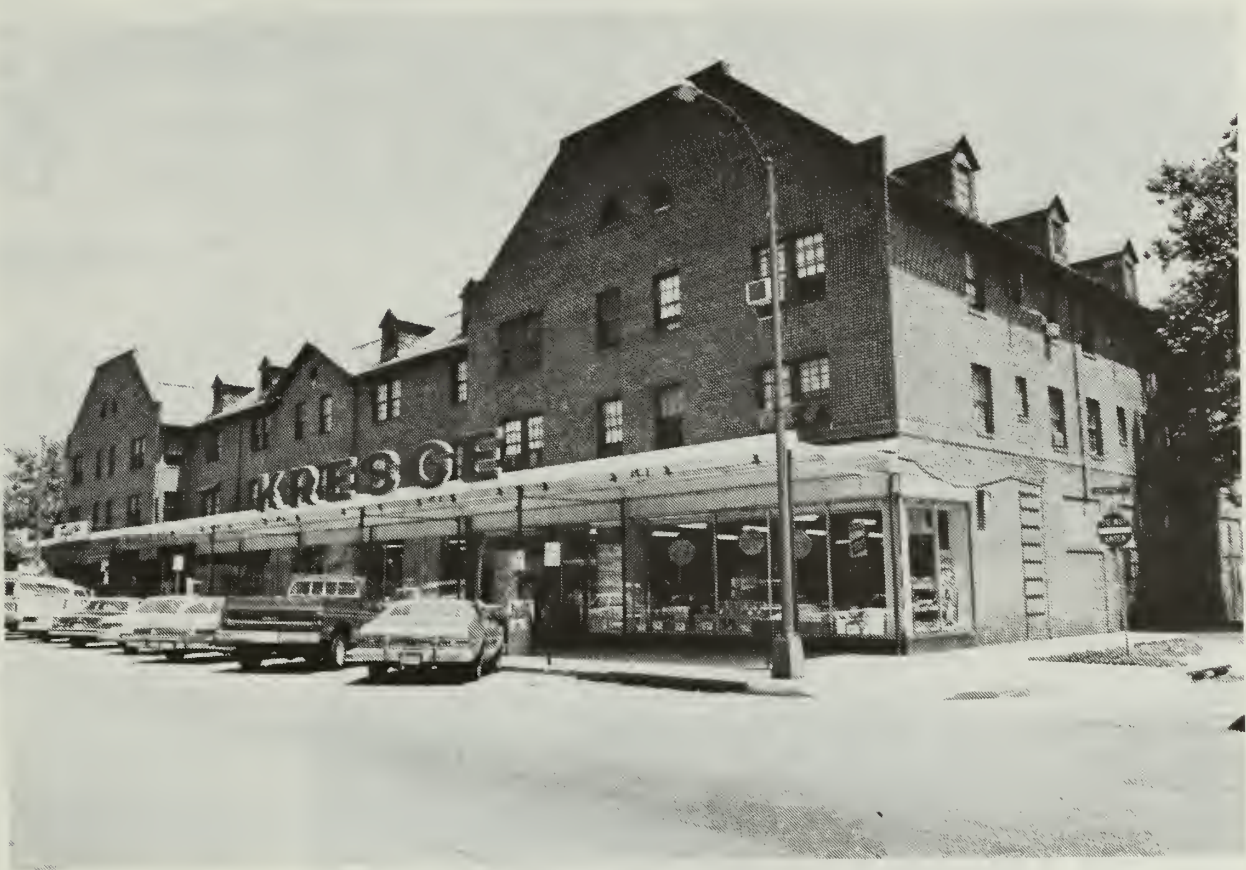
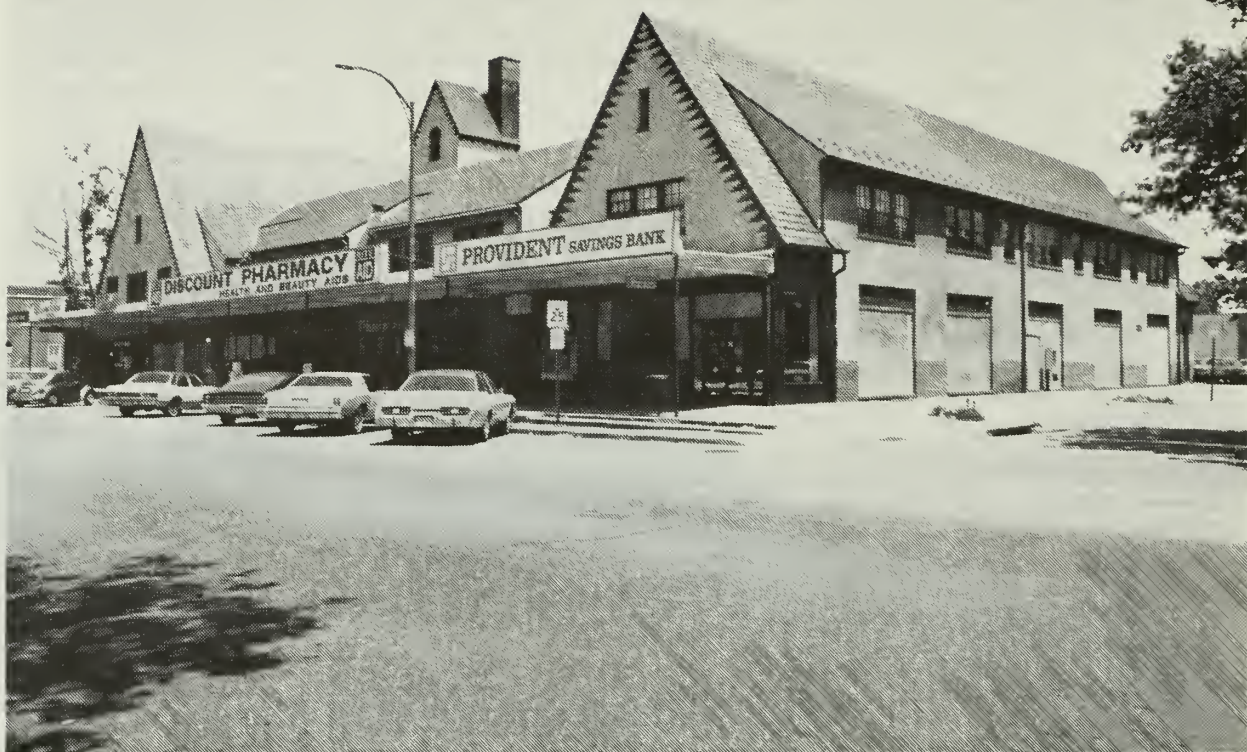
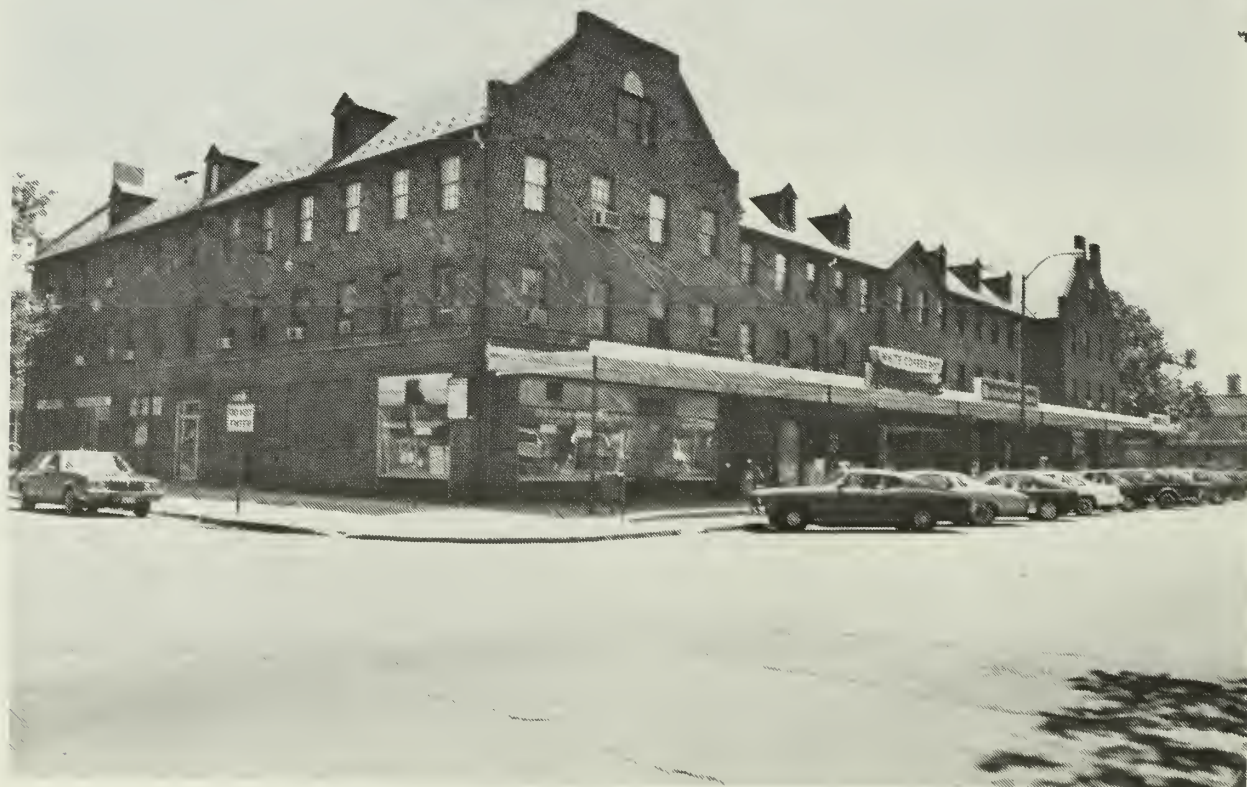
1-3 Pre-rehabilitation views demonstrate the residential scale of the second and third floor windows. Note how the dark color of the window sash and frames makes the windows less prominent on the upper floors of buildings 2 and 3.

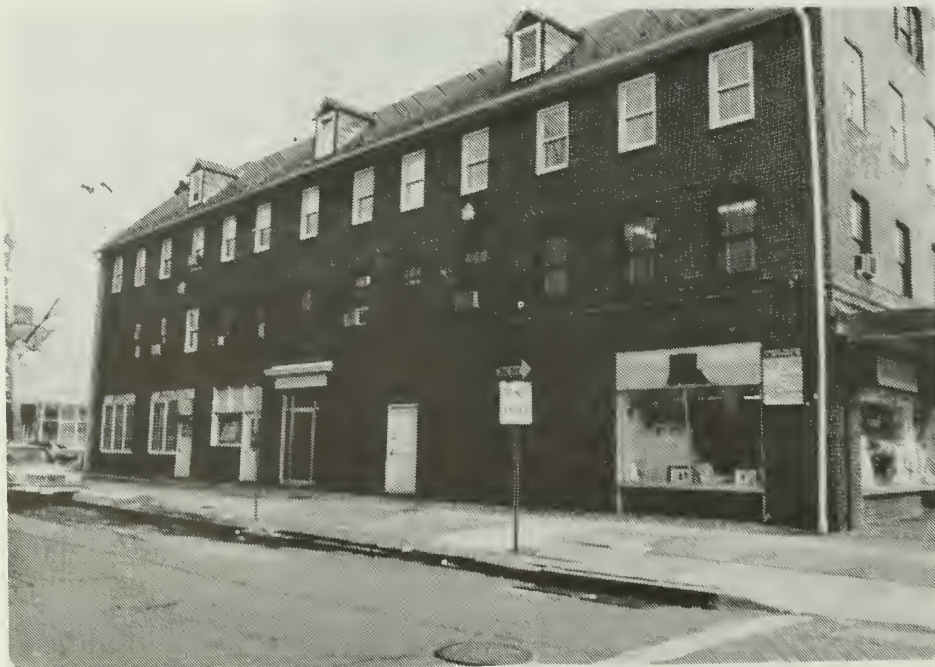
8. Proposed replacement windows on third floor and original windows below. Note how dark sash and frames are unobtrusive, light sash and frames create a striking pattern on the red brick facade.

Aluminum, double-hung windows with attached metal grids on the exterior and interior to simulate muntins were chosen to replace the originals (see illus. 6-7). Several of these windows were installed to evaluate their effectiveness in matching the adjacent historic windows. These windows were, however, determined not to adequately duplicate the visual qualities of the historic windows in their color, proportion, size, and installation detail of the originals. A light ivory color was chosen, rather than the dark green of the historic sash, causing the windows to stand out against the facade rather than to recede as the dark-colored historic sash had done (see illus. 8). The new

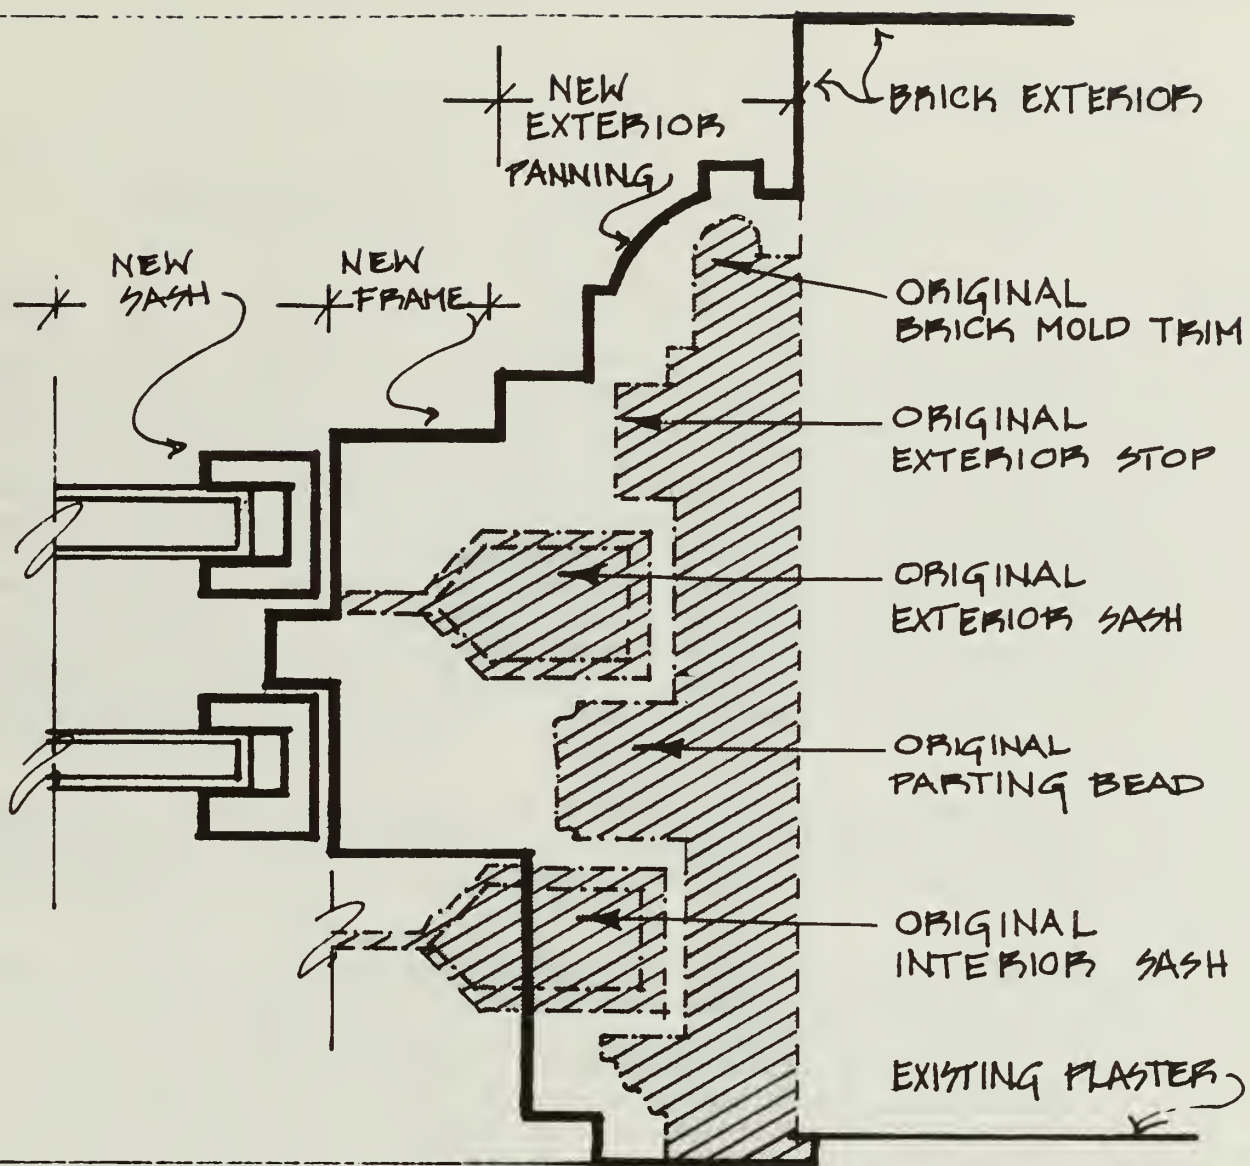
9. Drawing of proposed window and original window and frame location. Note how new sash and frame are set closer to the exterior and within the window opening. The owner's alternative panning identified above will not correct the deficiencies of the sash.

sash and frames were not properly sized to custom-fit the openings in the manner of the originals. As a result, the amount of glass area was reduced and the delicately-designed appearance of the historic frames and sash was replaced by a much heavier appearing unit. The meeting rails of the replacement unit were almost twice the thickness of the historic ones, and the grids, although trapezoidal-shaped, were significantly wider than the historic muntins. The blocking of the opening reduced the sash area while significantly increasing the exposure of the frame with its attached aluminum subframe and metal panning. The flat metal panning bore no relationship in size or profile to the historic wood molding detail found around the frames of many of the historic windows in the buildings. It also was proposed that the mullions in the multiple window bays be covered in metal in a manner that would eliminate the decorative edge detailing. Finally, the appropriateness of the metal grids on residential scale windows of this type on low-rise buildings was a questionable treatment. These numerous deficiencies resulted in denial of certification for tax benefits.

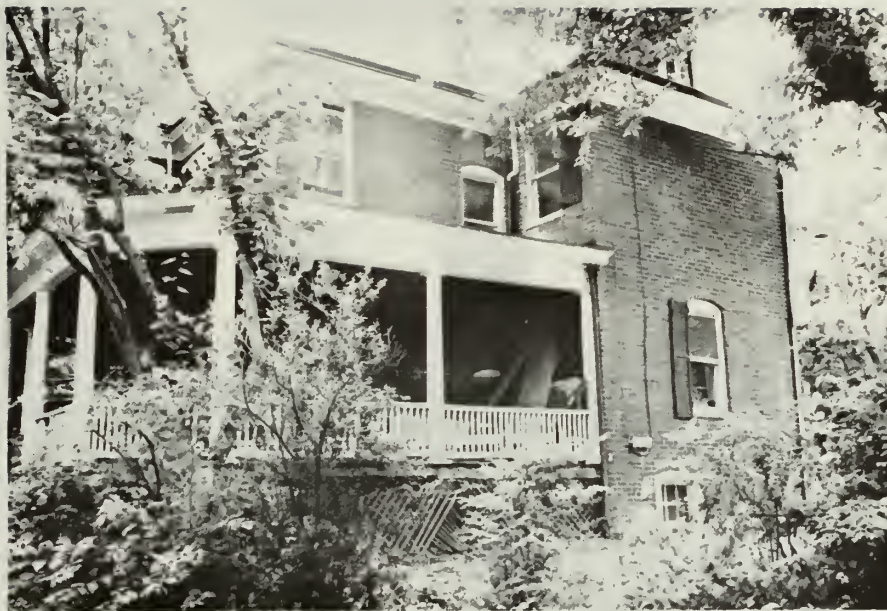
1. The c. 1915 freestanding residential structure is visible from all four sides; an unadorned brick side wall is a foil for the most distinguishing feature of the house--the wood wraparound porch.

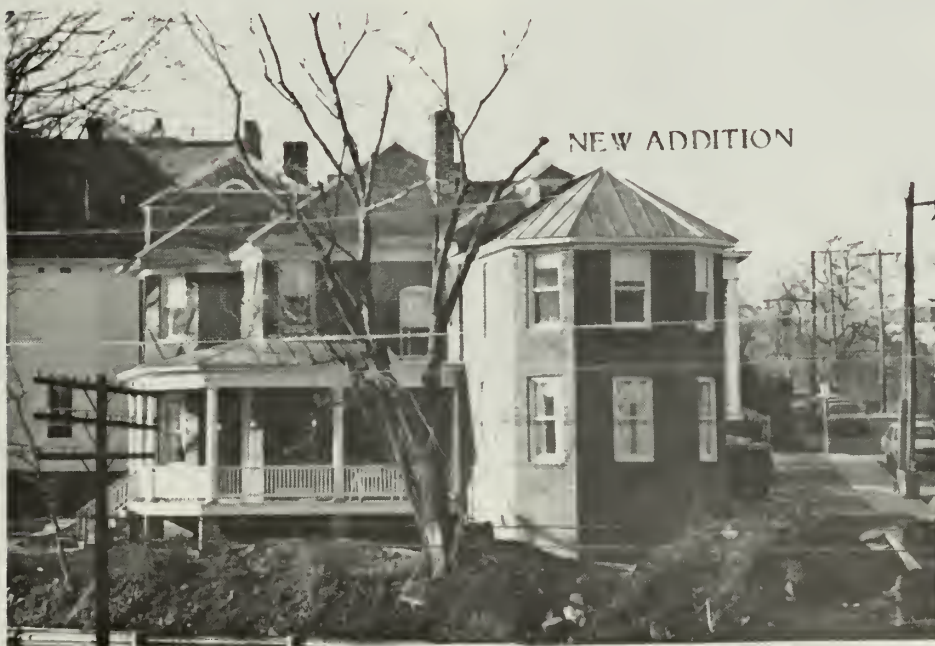
2. A new dormitory wing has been constructed on the side elevation shown in illustration 1. Because of its height, degree of projection, distinctive shape, and high visibility, the new addition has become the dominant feature of the house and has changed the historic character.

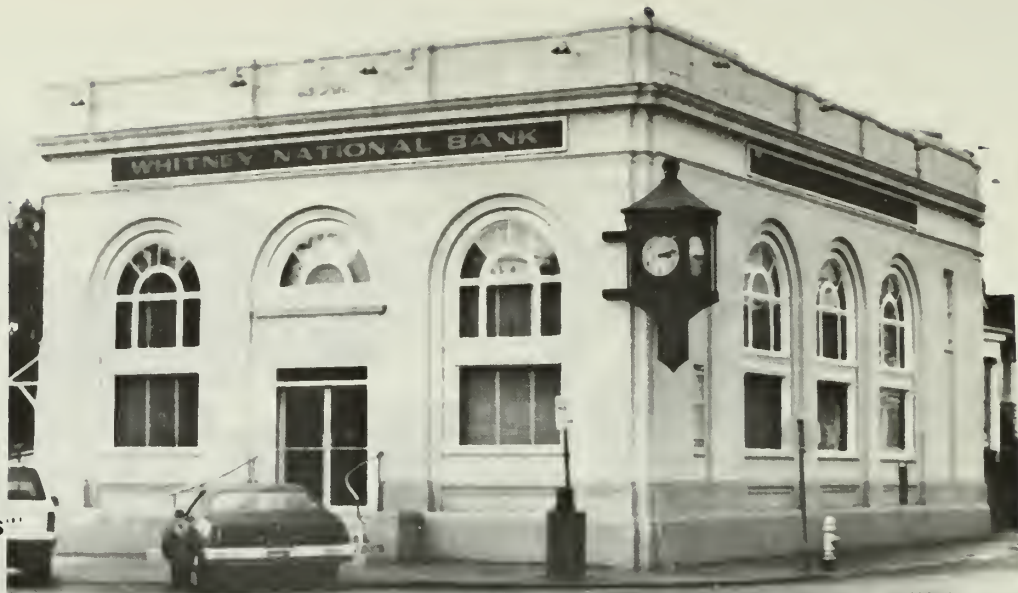
3. This freestanding bank structure, located at a major intersection in the district, was readily identifiable before rehabilitation by its simple rectangular form and its large, arched openings.

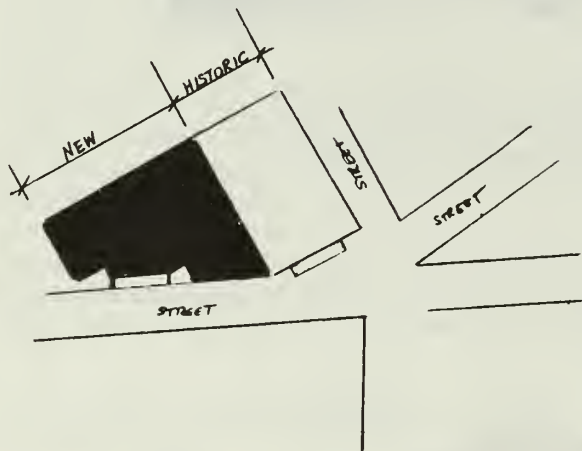
4. The historic bank and new bank addition are shown in relationship to the surrounding streets in the district. The previously rectangular form of the freestanding bank has been dramatically altered by both the size and shape of the addition.

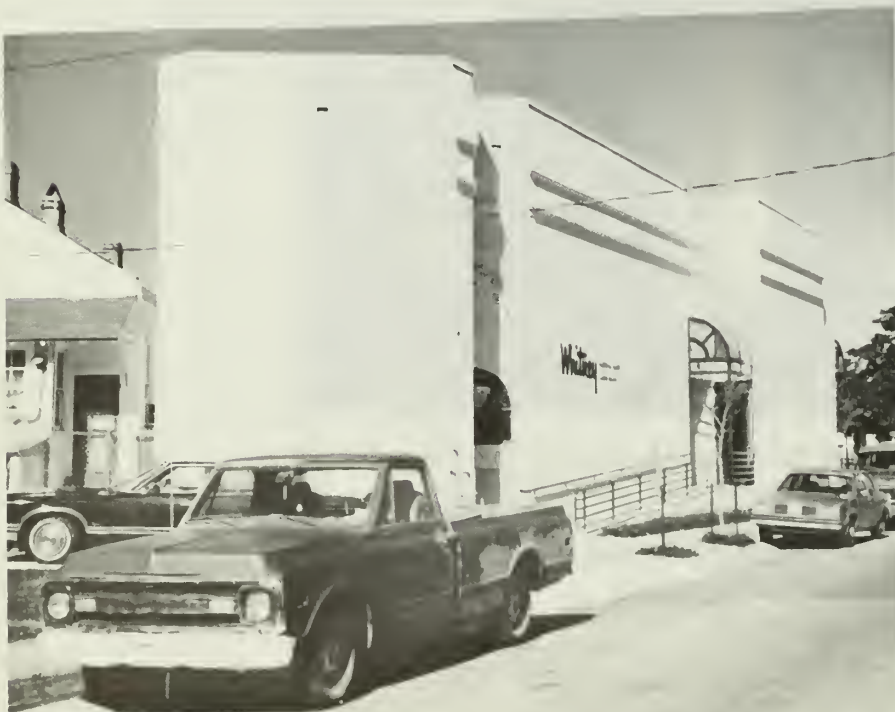
5. Even with a setback, appropriate height, compatible materials, and clear differentiation between new and old, the new work now dominates the resource and the setting. The historic bank can no longer be seen from a major side street.

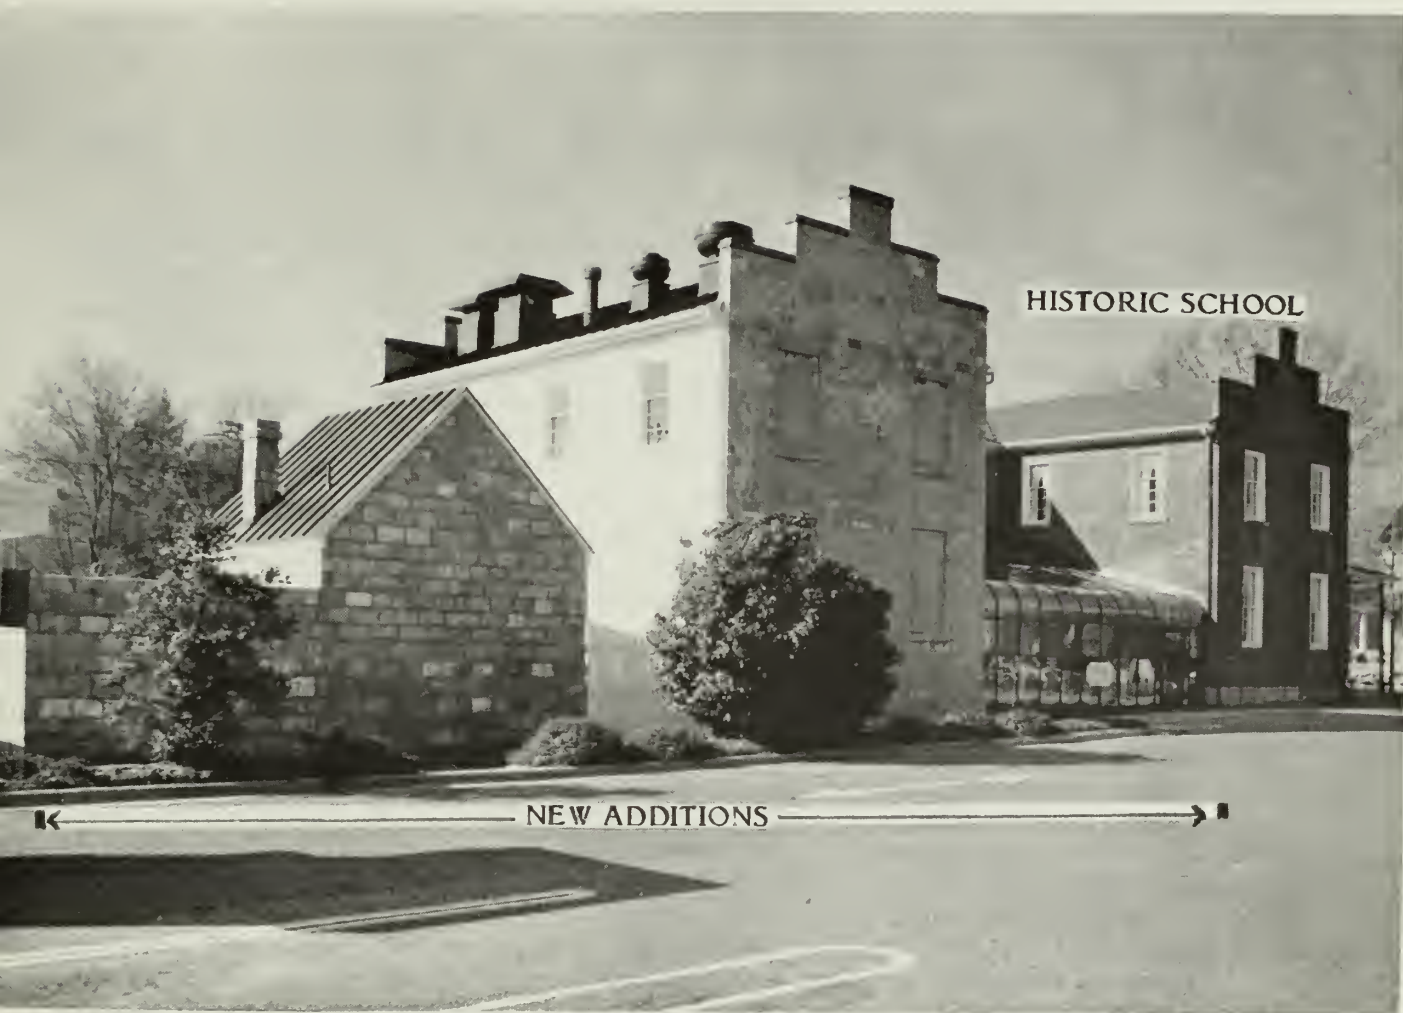
6. The side and rear elevation of the 1839 brick school building are shown here on the far right (the later ell is not visible) together with three new components added as part of the rehabilitation project--a greenhouse, a kitchen building with stepped gables matching the historic building, and a storage building. Because the new addition has changed the historic character to a dramatic degree, the project was denied tax incentives. A smaller kitchen wing--planned and sited differently--could have been in conformance with the Standards. The greenhouse itself was not an issue.

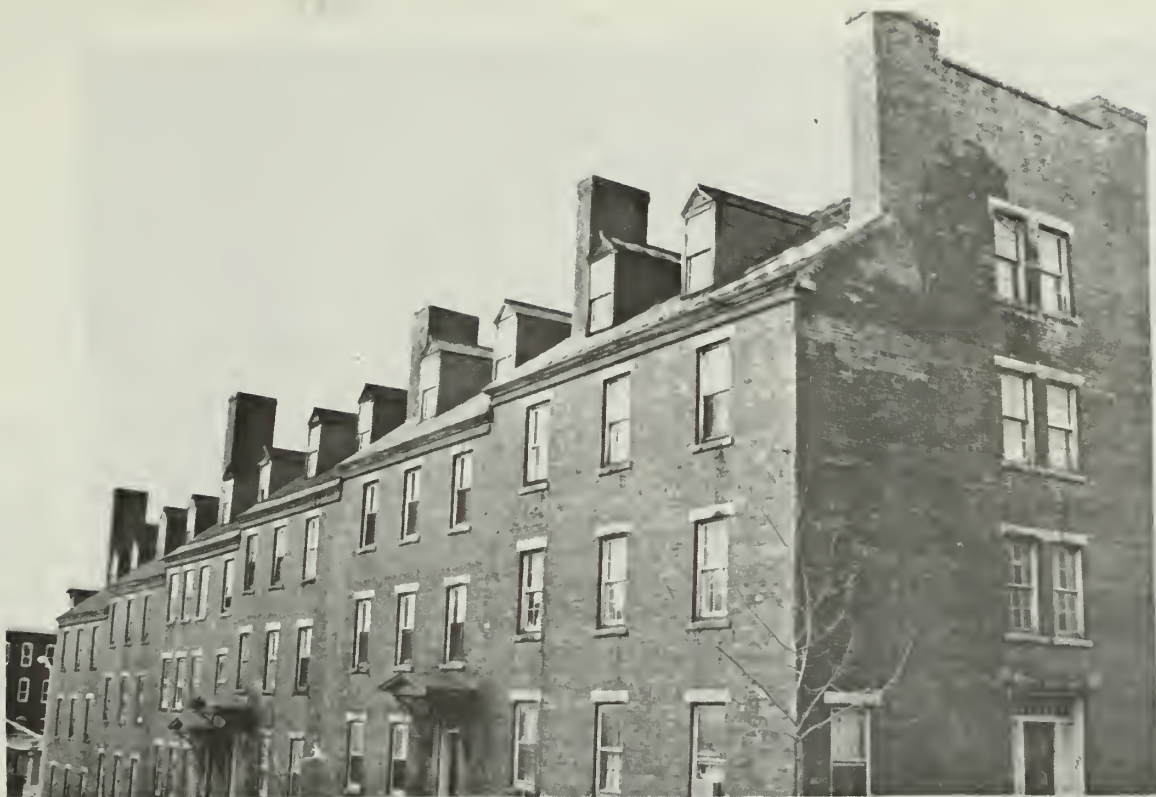
1. The historic character of the structures as mill workers' housing remained; that character, as NPS noted, was still forcefully conveyed by both the exterior and the interior.

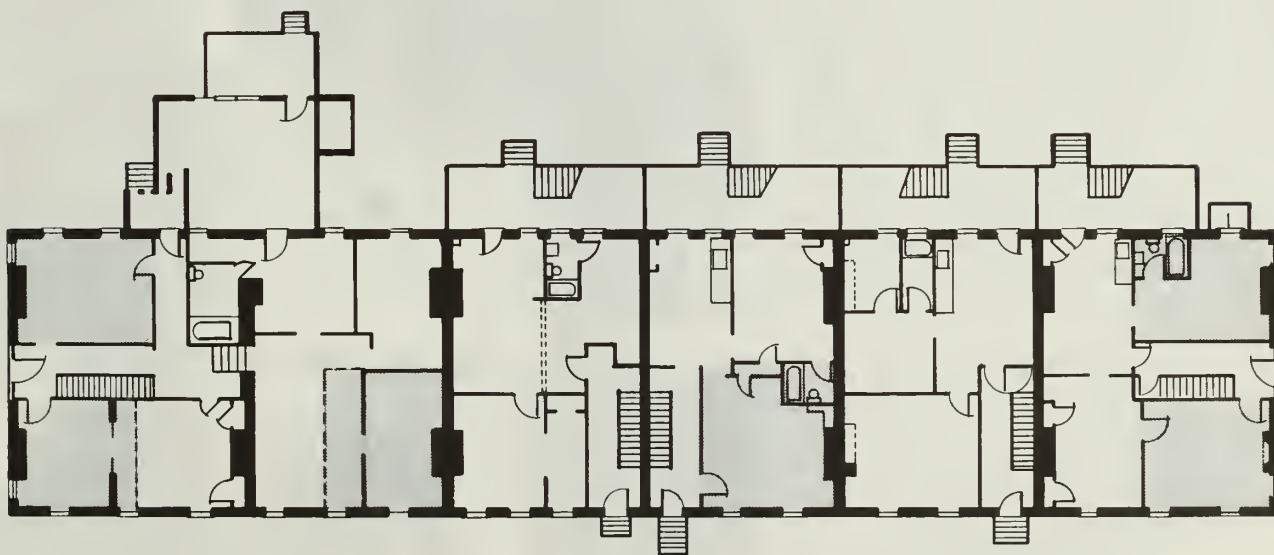
2. The plan shows room size and arrangement; units converted to two-story spaces by cutting through the first floor are denoted by shadowing.

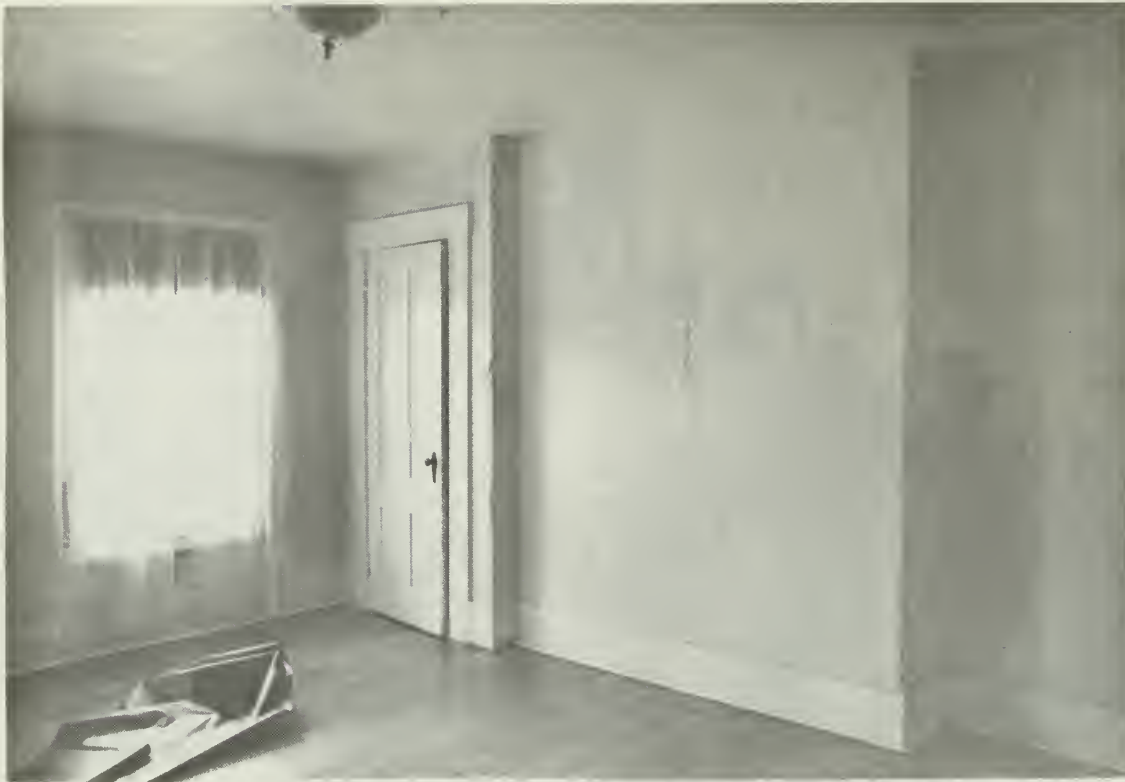
3. A typical room prior to rehabilitation. defined by its low ceiling, rectangular space, and simplicity of detailing.

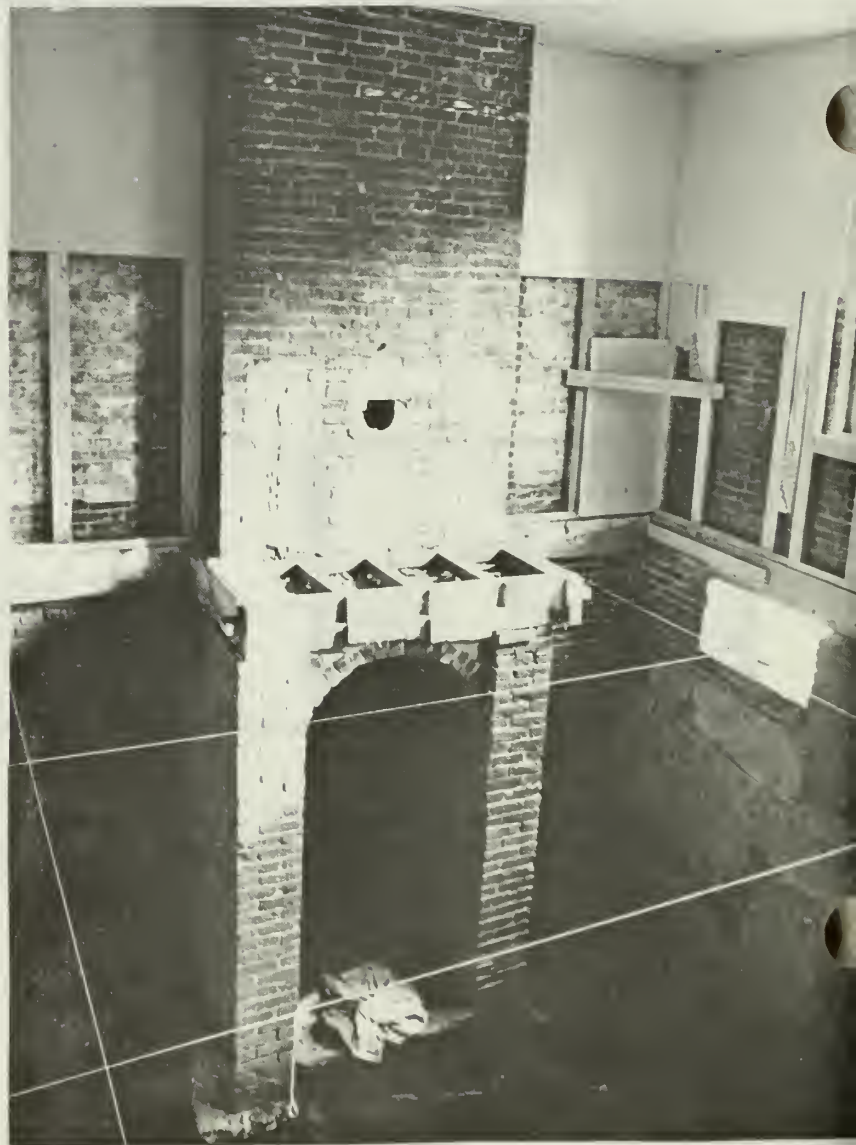
4. As part of the rehabilitation, the historic space was dramatically redefined by removing the first story floor, revealing the basement level. Two separate rectangular spaces were then made into one rehabilitated living unit. This inappropriate treatment violated both Standards 2 and 9.

The character of the historic interior spaces appears to have been easily adaptable for modern residential use. Unfortunately, during the course of your rehabilitation work on these units, large portions of the first floors were removed in order to create two-story spaces. The creation of those two-story spaces required the destruction of both historic material and the distinguishing spatial concept of the most significant areas of each house, in violation of Standard 2.

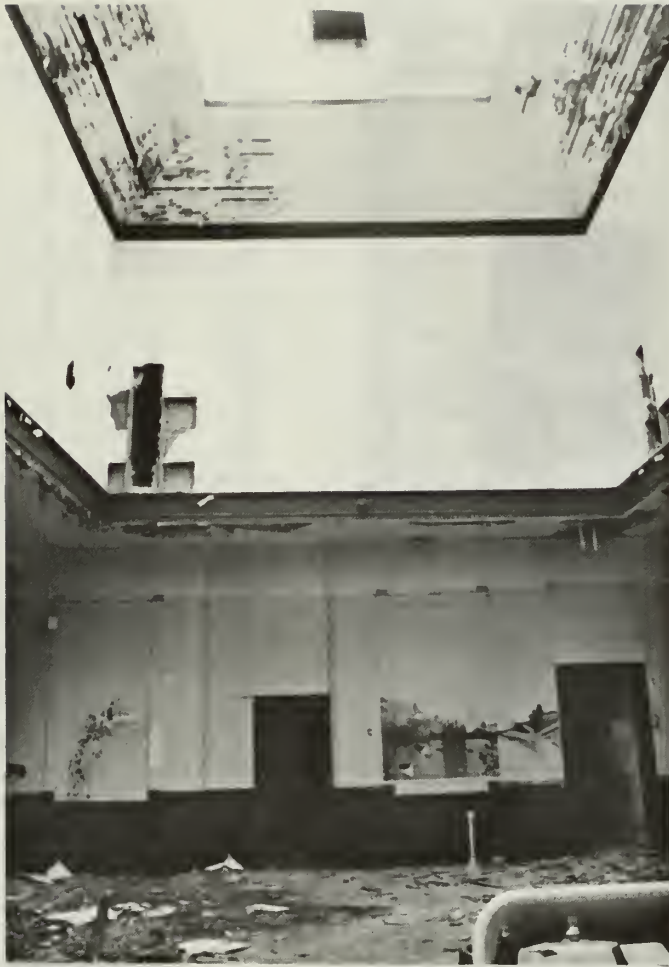
3. View of central space showing atrium extending through the second and third floors, with skylight above. The second floor doors shown lead to rooms beyond. Windows have been blocked in, but their configuration is still apparent from the surrounding trim. On the third floor the open hallway had been partitioned.

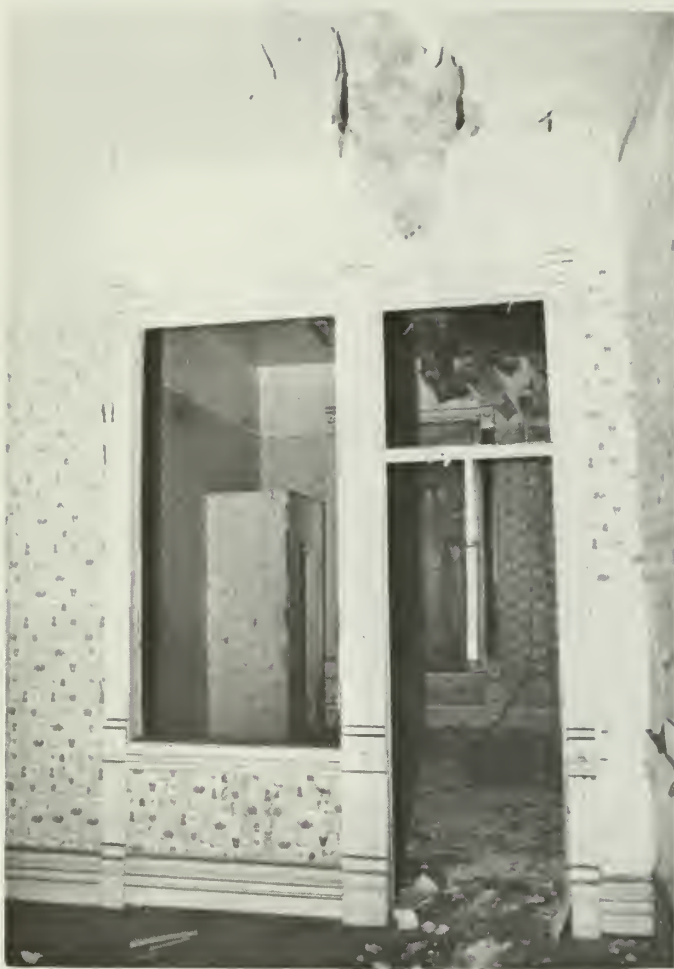
4. Interior rooms were fitted with windows and doors with transoms to borrow light from both the exterior window walls and the rooms facing the lighted atrium.

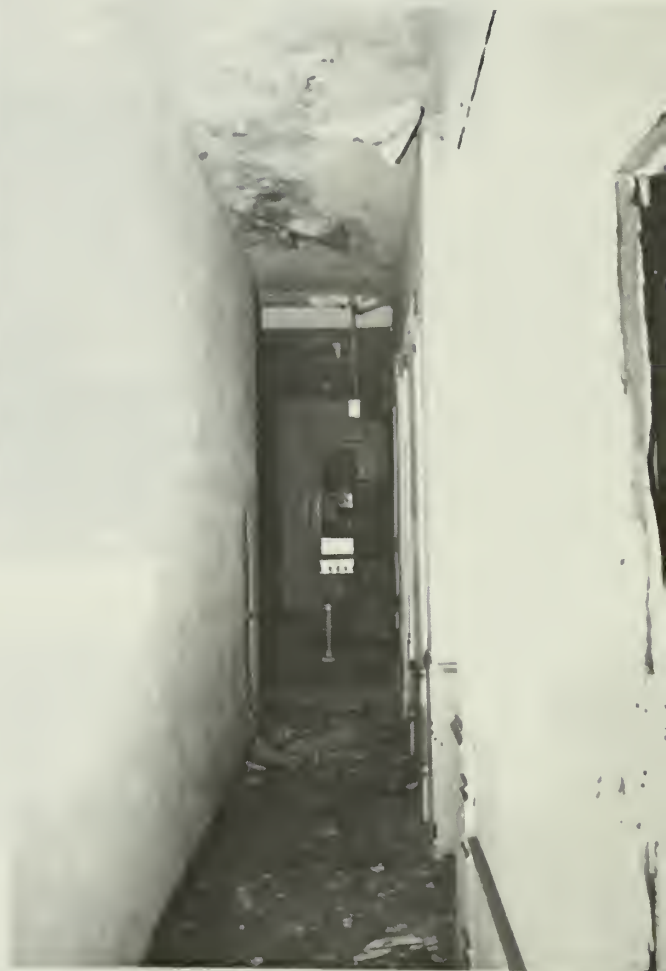
5. On the third floor, the historic hallway, originally open, had been fitted with a solid partition; the offices behind it, however, were relatively unaltered.

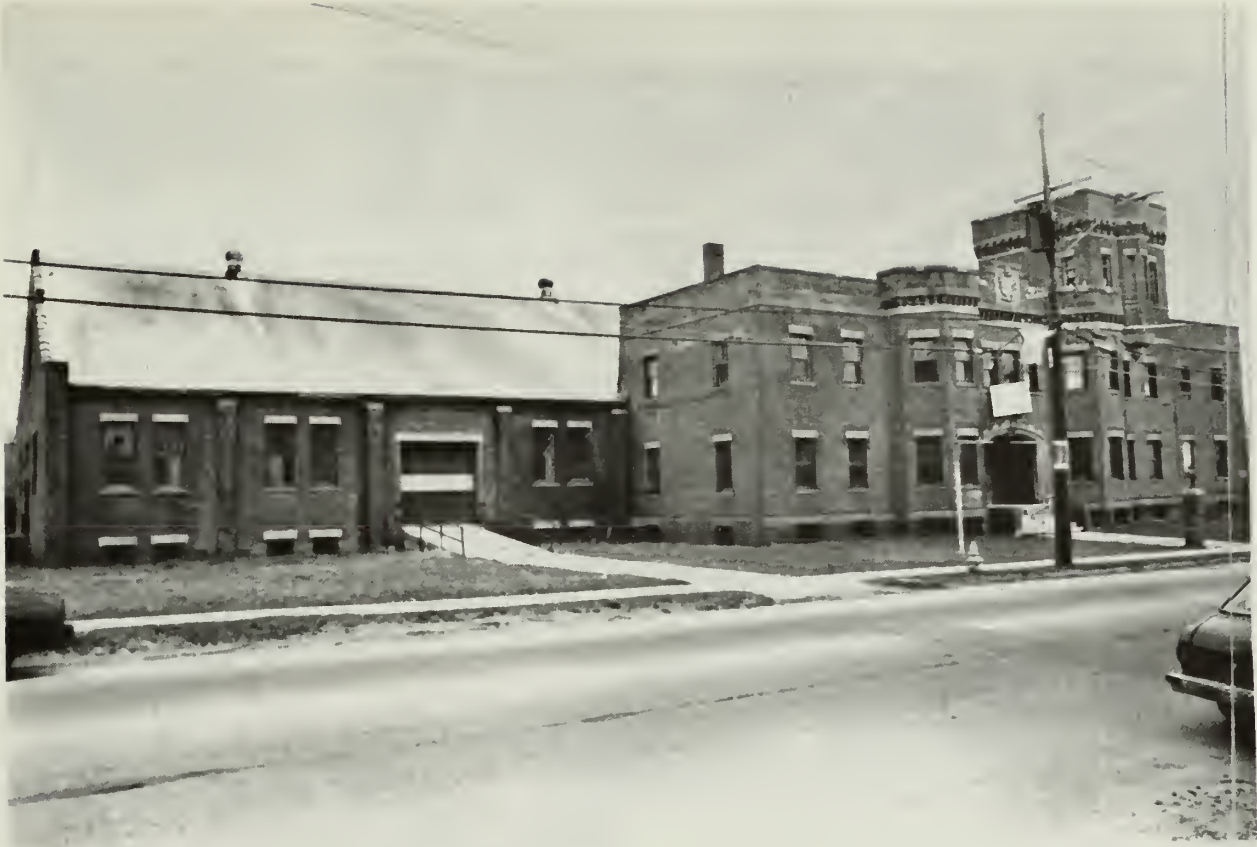
1. The facade of the armory before rehabilitation. The gable-roofed drill shed extends four bays beyond the head house with its three-story tower and three-sided corbelled bay.

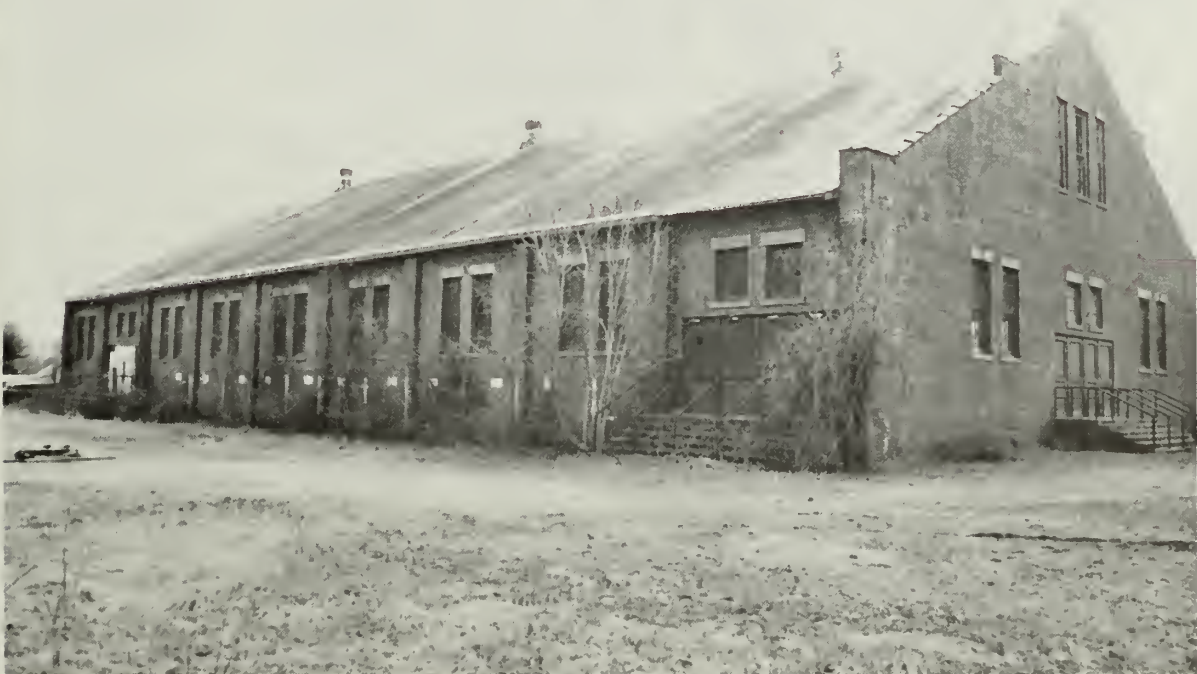
2. The rear elevation of the drill shed. Note the paired, nine-over-nine wood sash windows and the high sills which provide much of the character.
